APPENDIX A
NOTICE OF PREPARATION AND COMMENTS

CITY OF STOCKTON
NOTICE OF PREPARATION OF A DRAFT ENVIRONMENTAL IMPACT REPORT

SUBJECT: ENVIRONMENTAL IMPACT REPORT FOR THE SANCHEZ-HOGGAN ANNEXATION PROJECT

PROJECT TITLE: Sanchez-Hoggan Annexation Project
CITY PROJECT FILE #: P19-0691

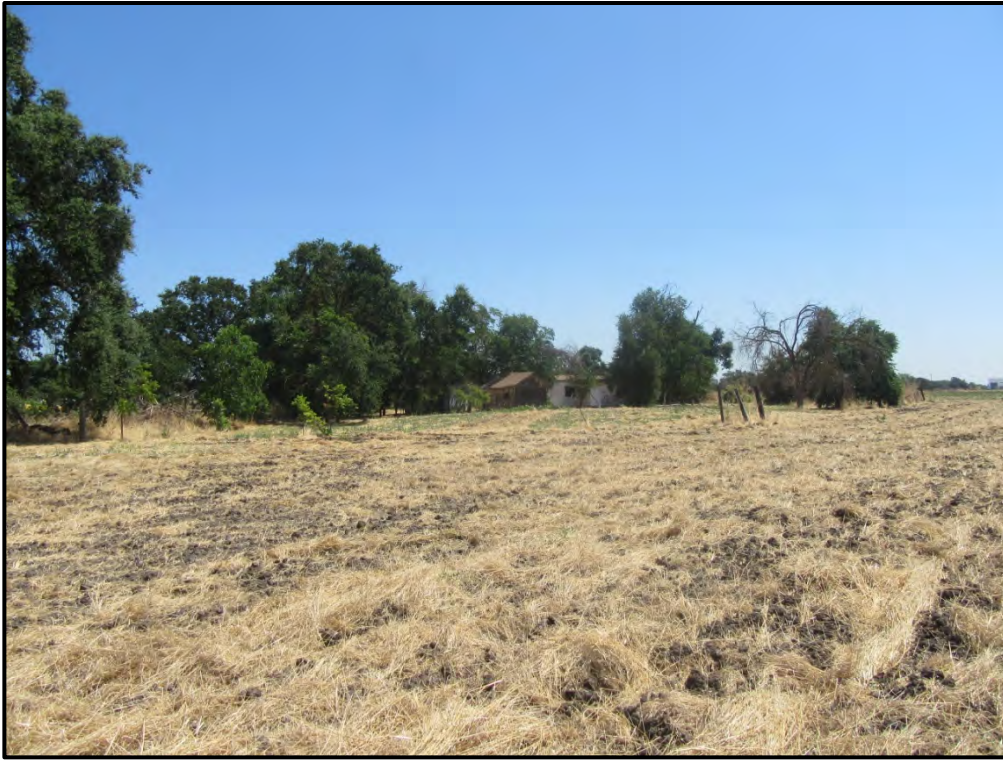
Large trees surrounding the abandoned residence in the northeast corner of the 20+/- acre parcel, looking northeast; 07/05/19. No nesting birds were observed in these trees.

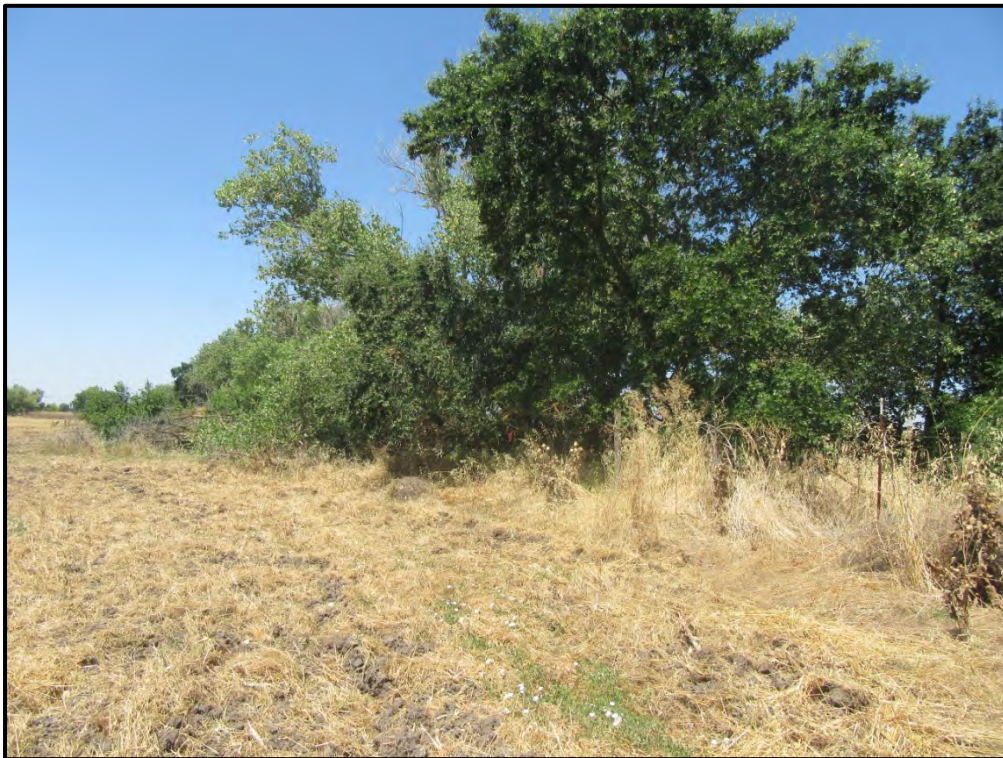
Riparian corridor along North Littlejohn Creek along the north edge of the 20+/- acre parcel, looking west; 07/05/19.

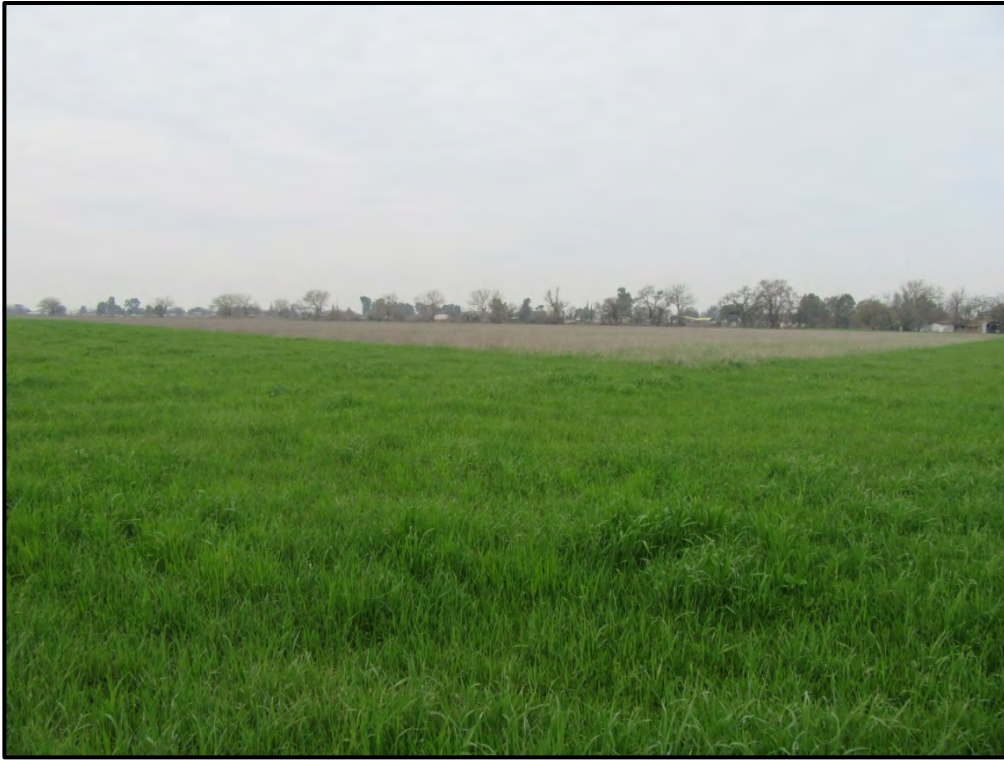
Annual grassland found in the body of the 20+/- acre parcel, looking northwest from the southeast corner of the parcel; 01/28/19.

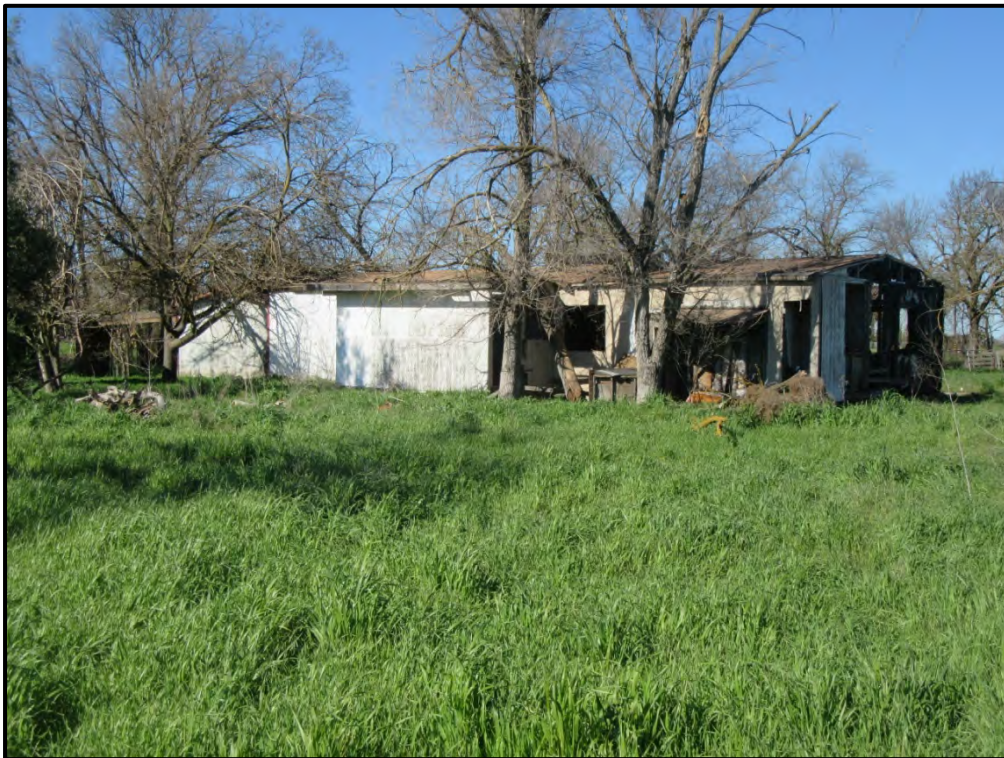
Abandoned residence in the northeast corner of the 20+/- acre parcel, looking northeast; 02/18/19. There are a few large trees and smaller dwellings in this area.

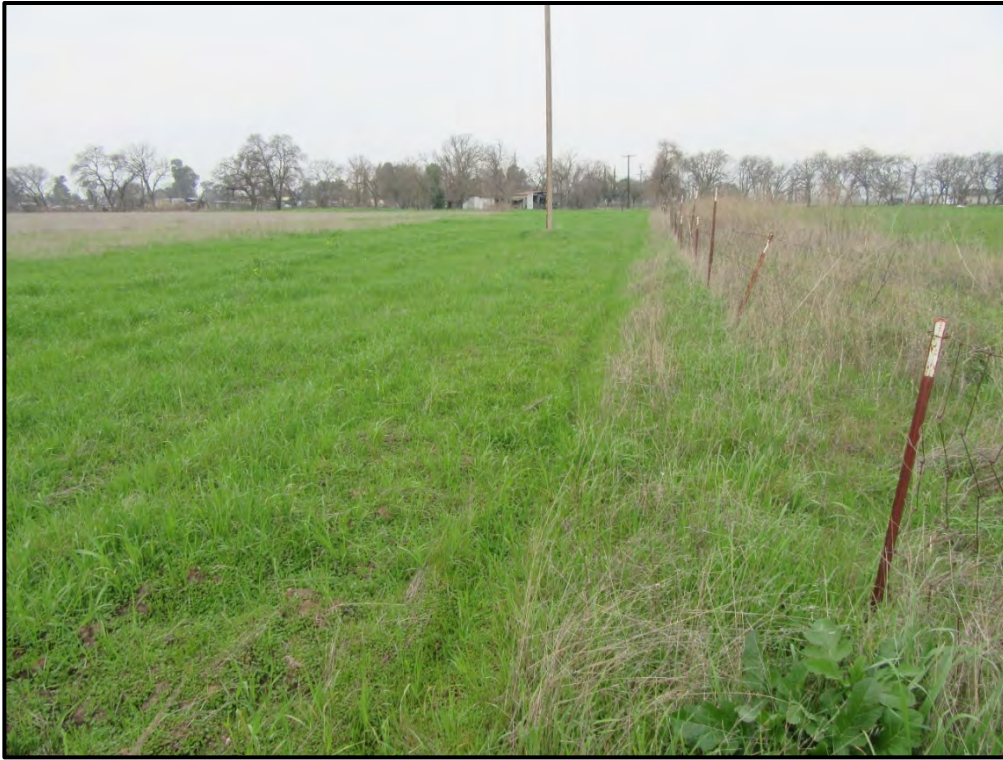
Fence line on the east edge of the 20+/- acre parcel, looking north; 01/28/19.

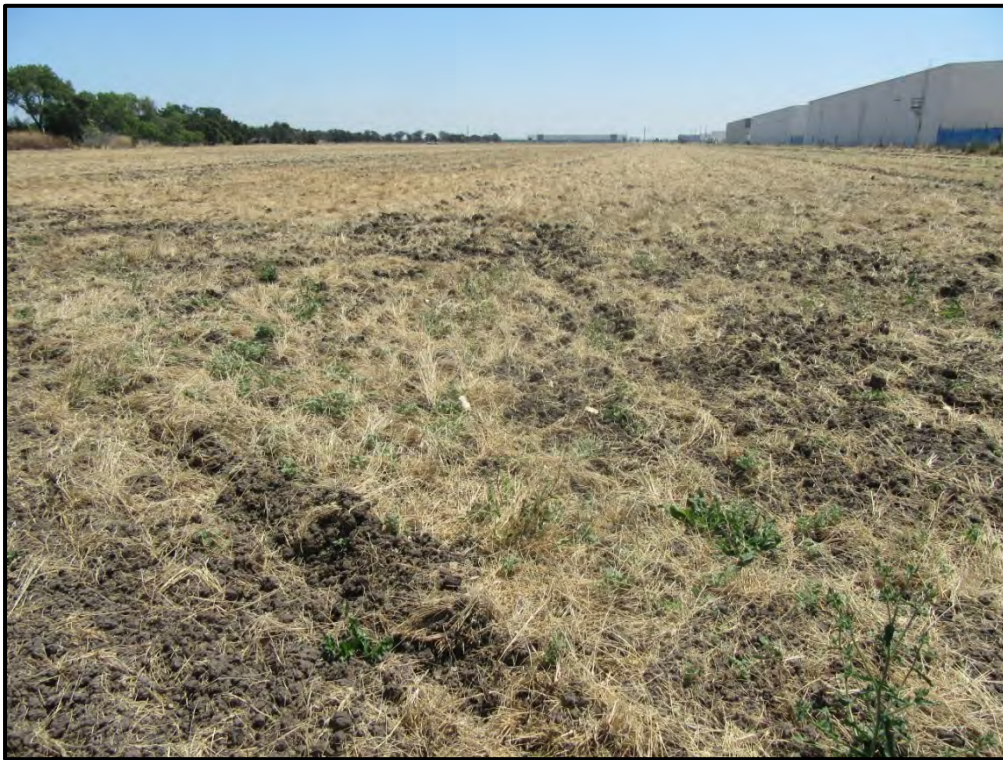
Recently disked grassland found in the body of the 20+/- acre parcel, looking east from the west part of the site; 07/05/19.

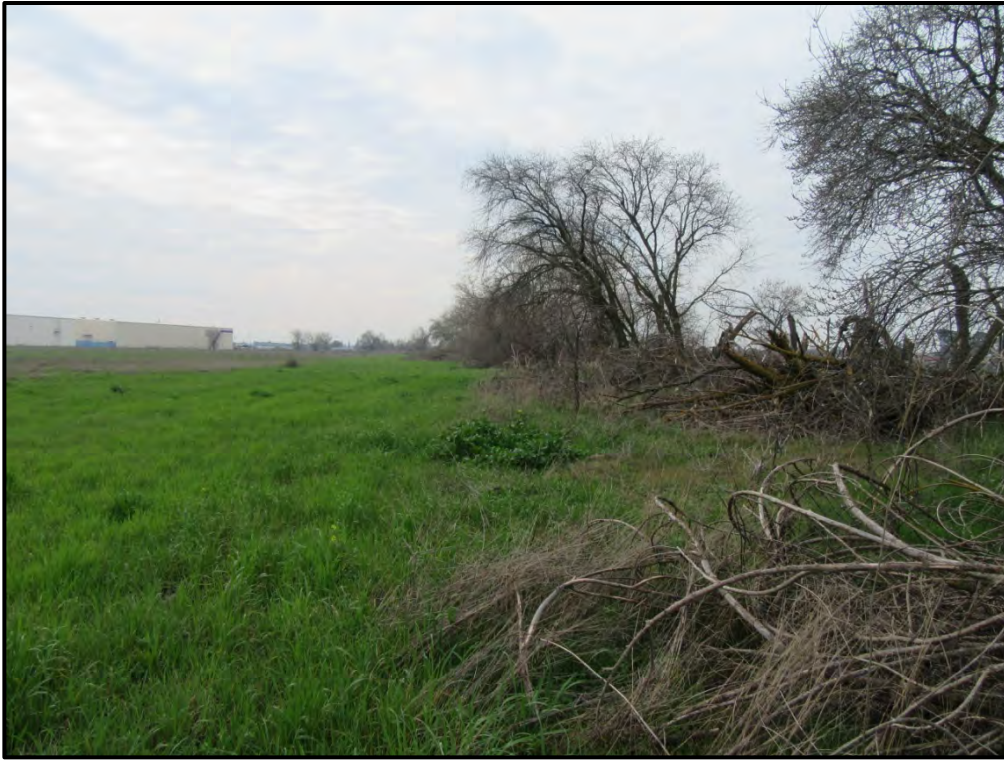
North Littlejohn Creek riparian corridor along the north edge of the 20+/- acre parcel, looking west; 01/28/19. Several of the trees were dead.

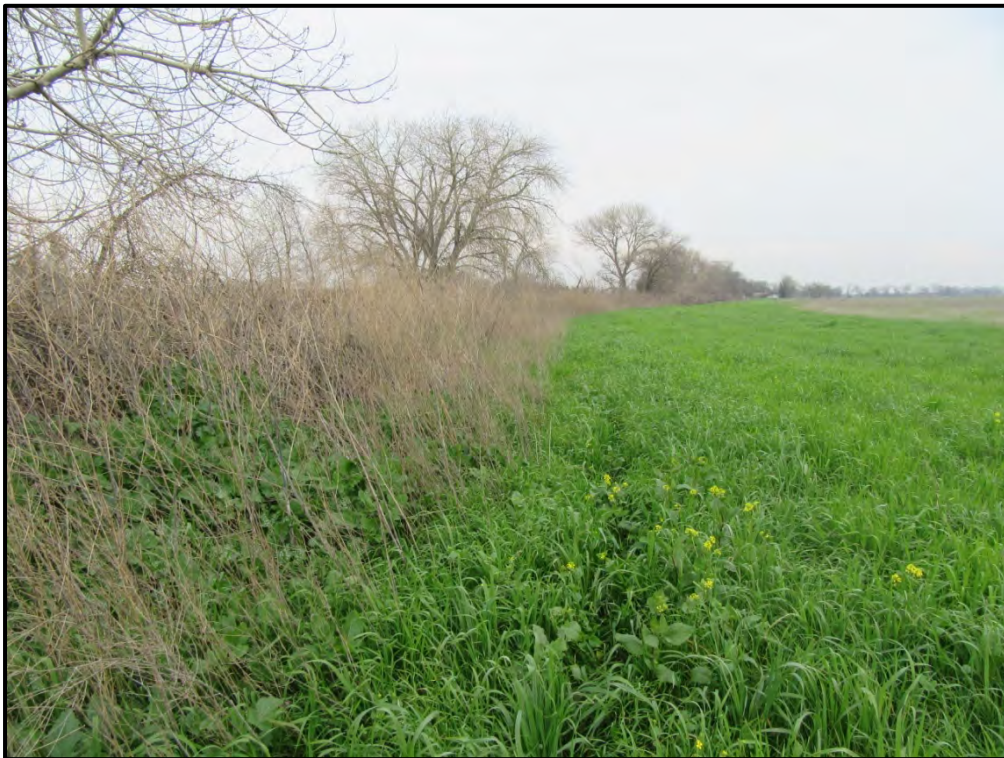
North Littlejohn Creek riparian corridor along the north edge of the 20+/- acre parcel, looking northeast. Valley oaks and cottonwoods are dominant trees along the creek.

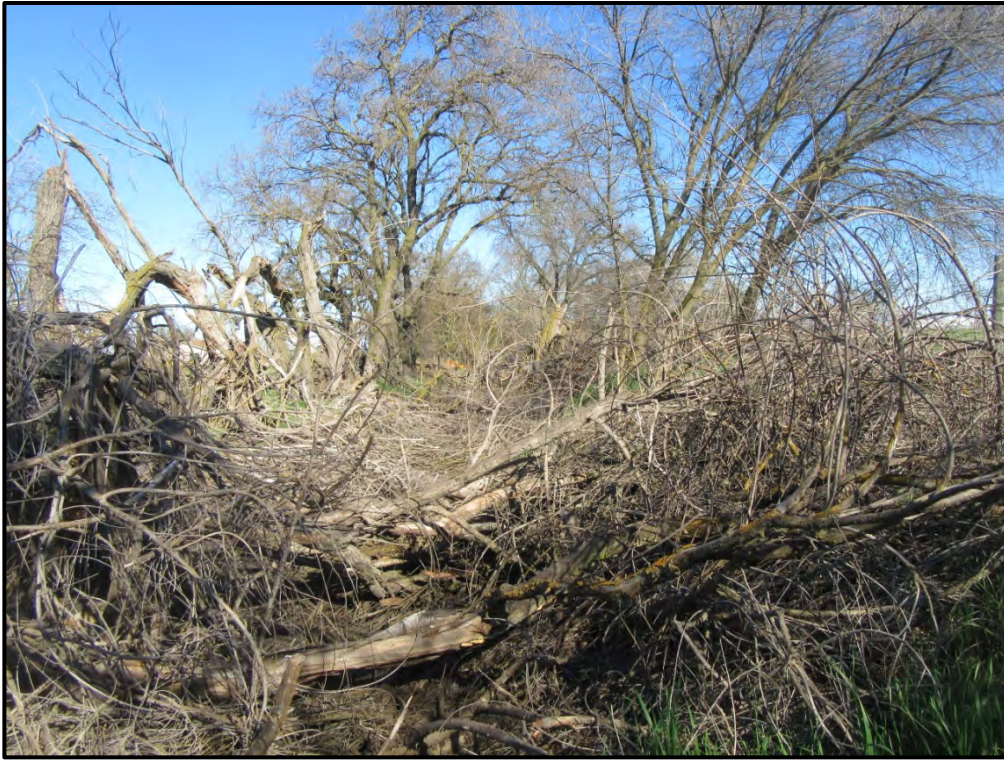
Downstream end of North Littlejohn Creek, looking southwest along the north edge of the 20+/- acre parcel; 02/18/19.

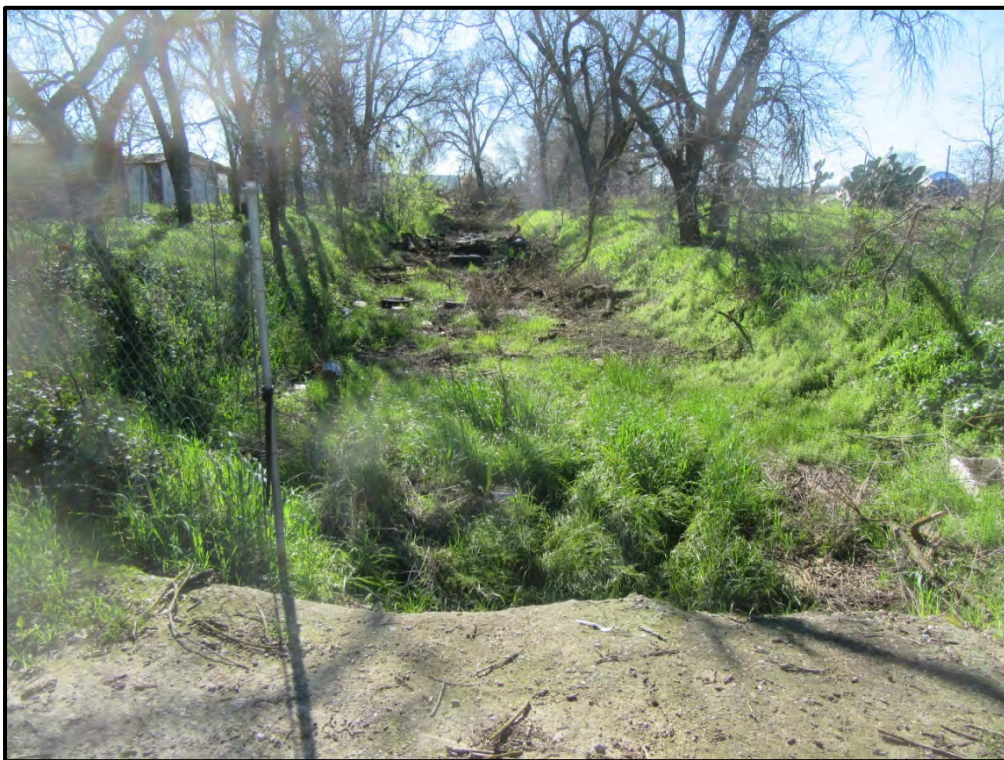
Upstream end of North Littlejohn Creek, looking southwest down the creek from the northeast part of the 20+/- acre parcel; 02/18/19.

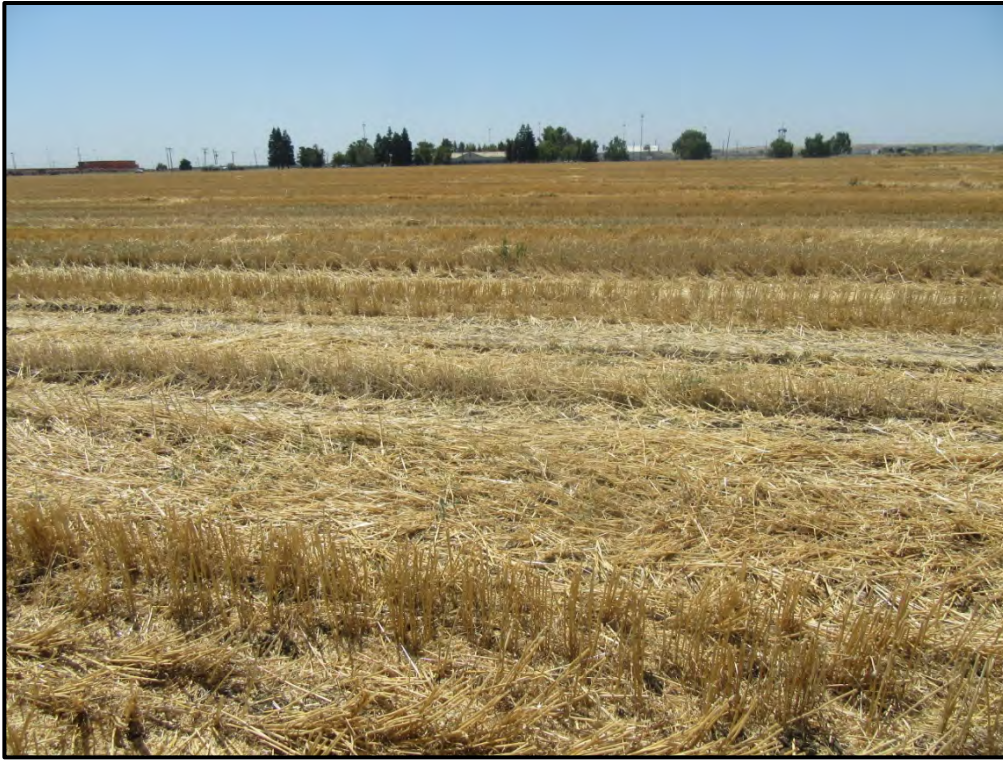
Body of the 149+/- acre site, looking south from the farm road adjacent to Weber Slough in the center of the site; 07/05/19. This site has recently been farmed in hay.

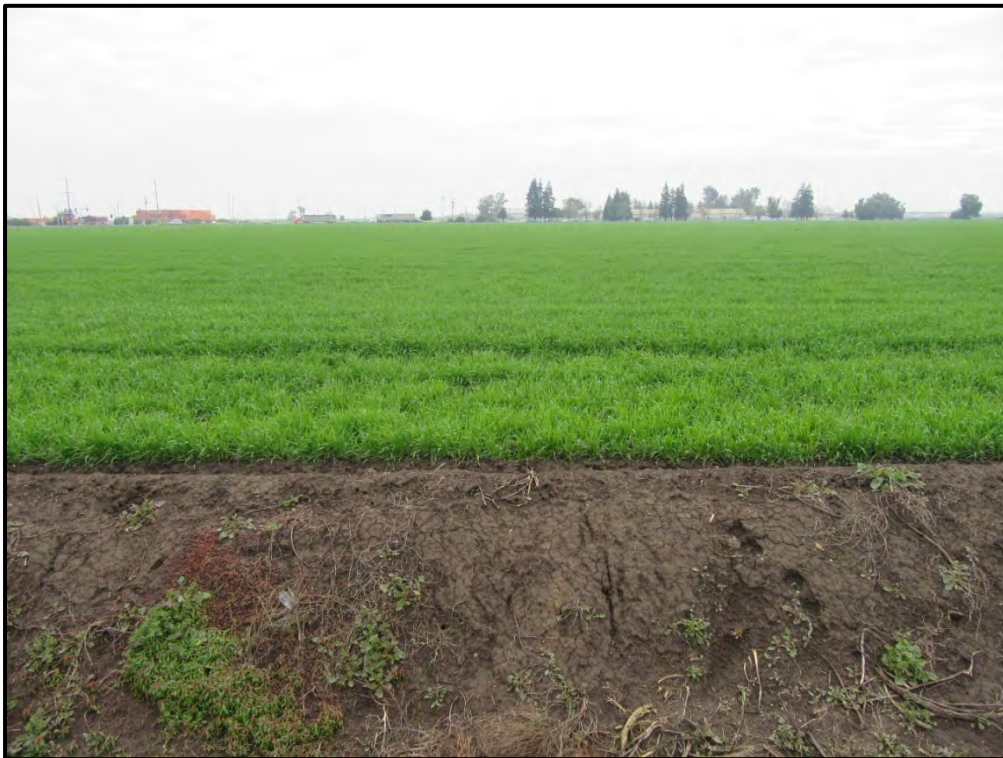
Recently sprouted winter hay crop in the 149+/- acre parcel, looking south from the edge of Weber Slough in the center part of the parcel; 01/28/19.

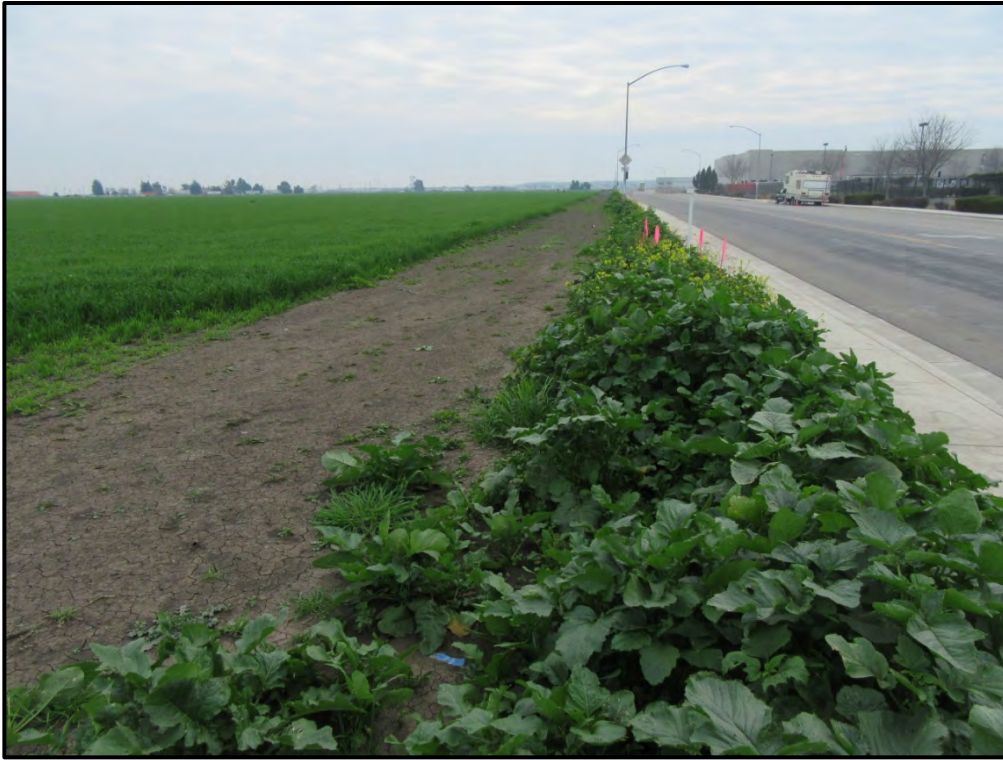
West edge of the 149+/- acre parcel, looking south along Logistics Drive from the northwest corner of the parcel; 01/28/19.

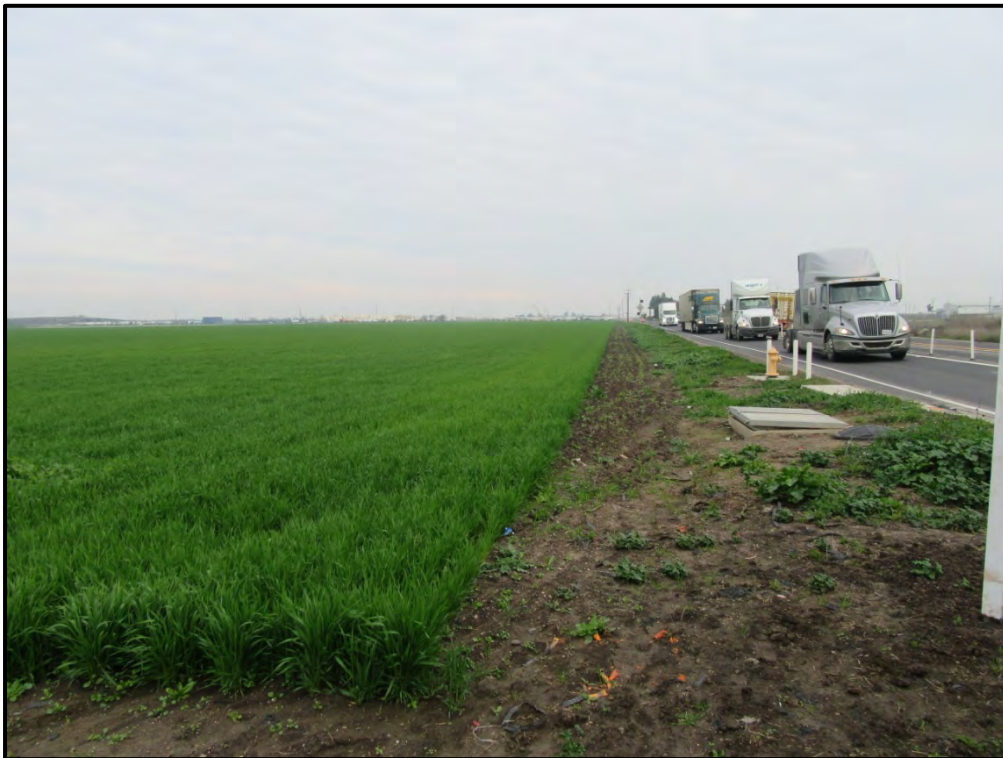
South edge of the 149+/- acre parcel, looking east along Arch Road from the southwest corner of the parcel; 01/28/19.

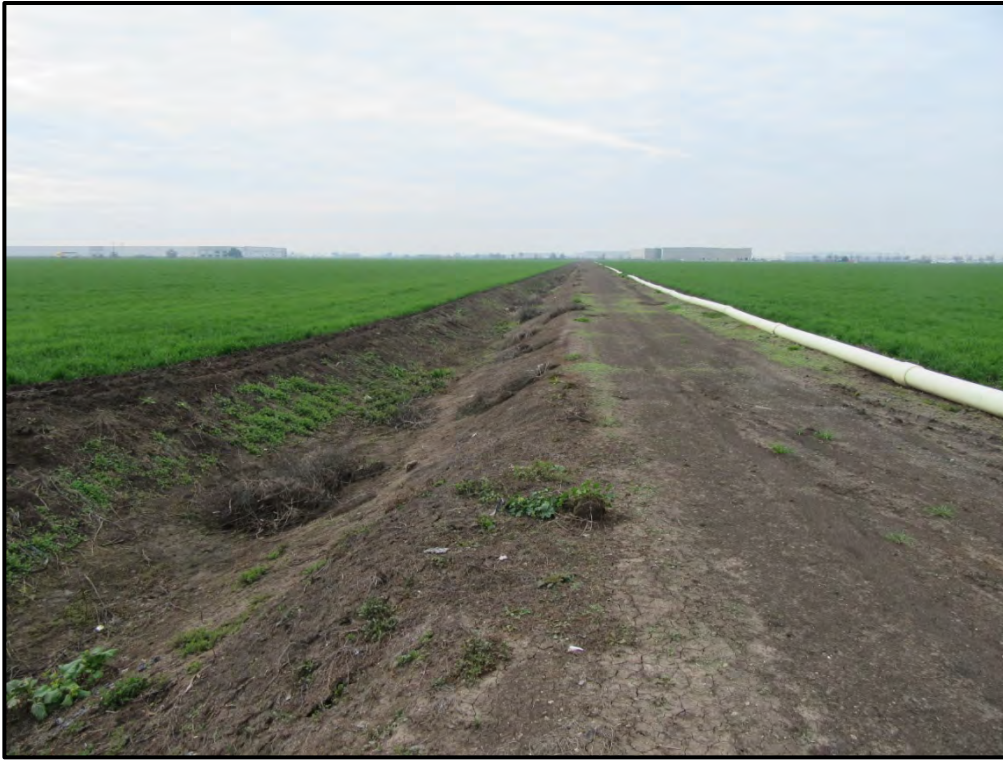
Farm road and Weber Slough that extends through the body of the 149+/- acre parcel, looking west from the east edge of the parcel; 01/28/19.

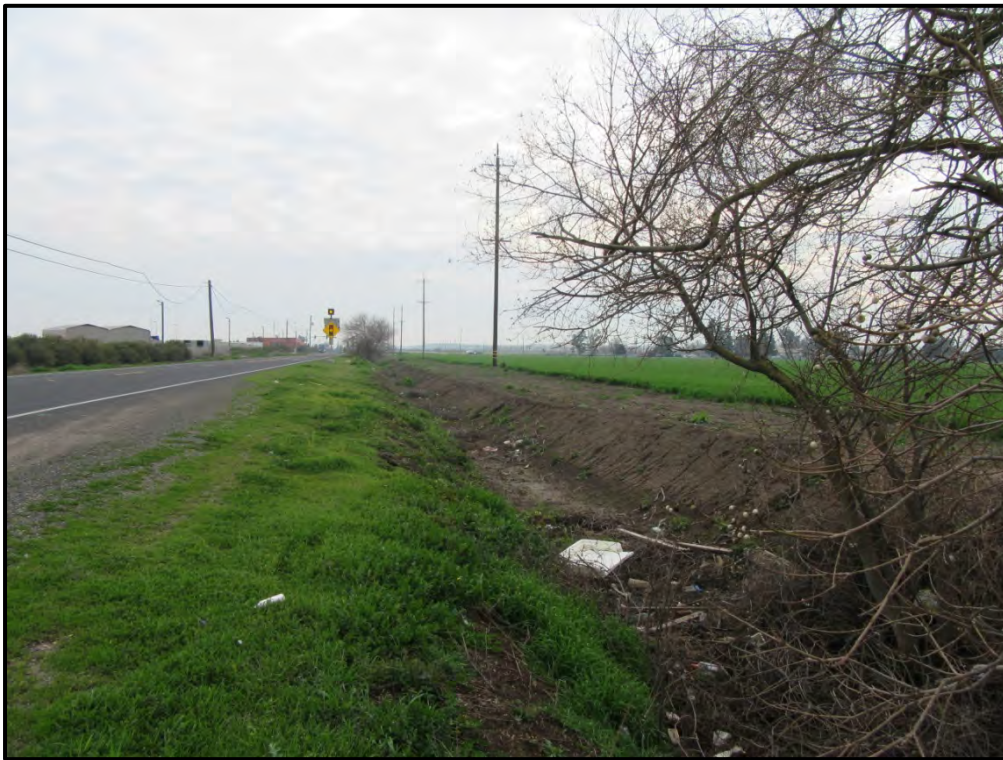
Weber Slough along the east edge of the 149+/- acre parcel, looking south from the west road shoulder of Austin Road; 01/28/19.

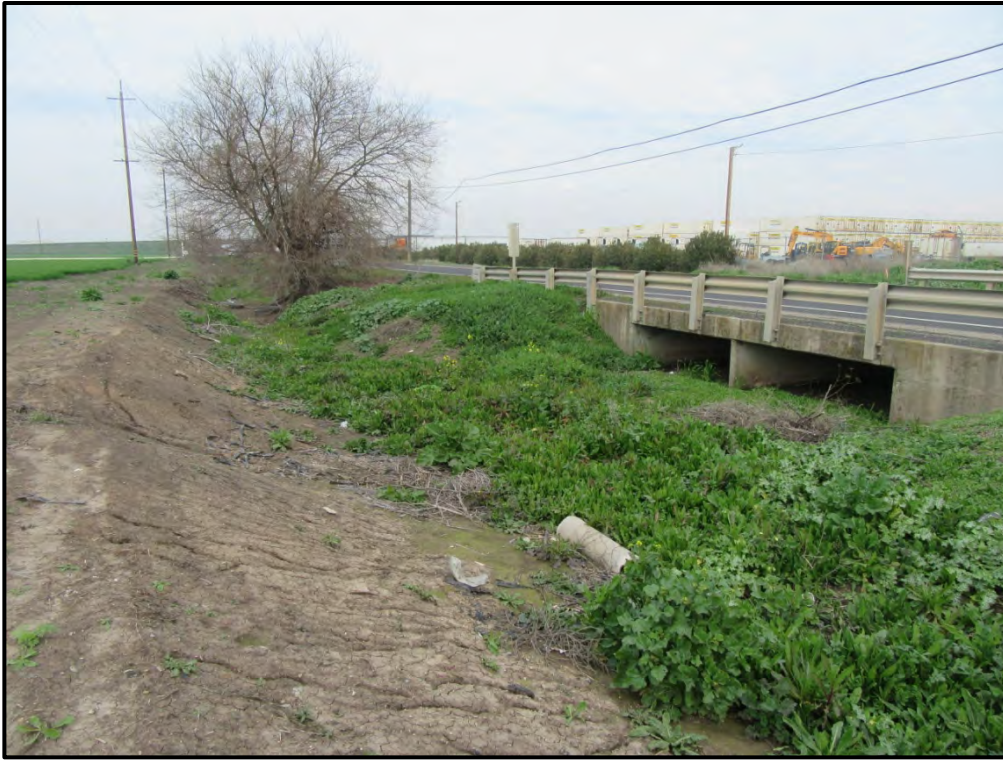
Location where Weber Slough enters the 149+/- acre parcel through a culvert under Austin Road, looking northeast; 01/28/19.

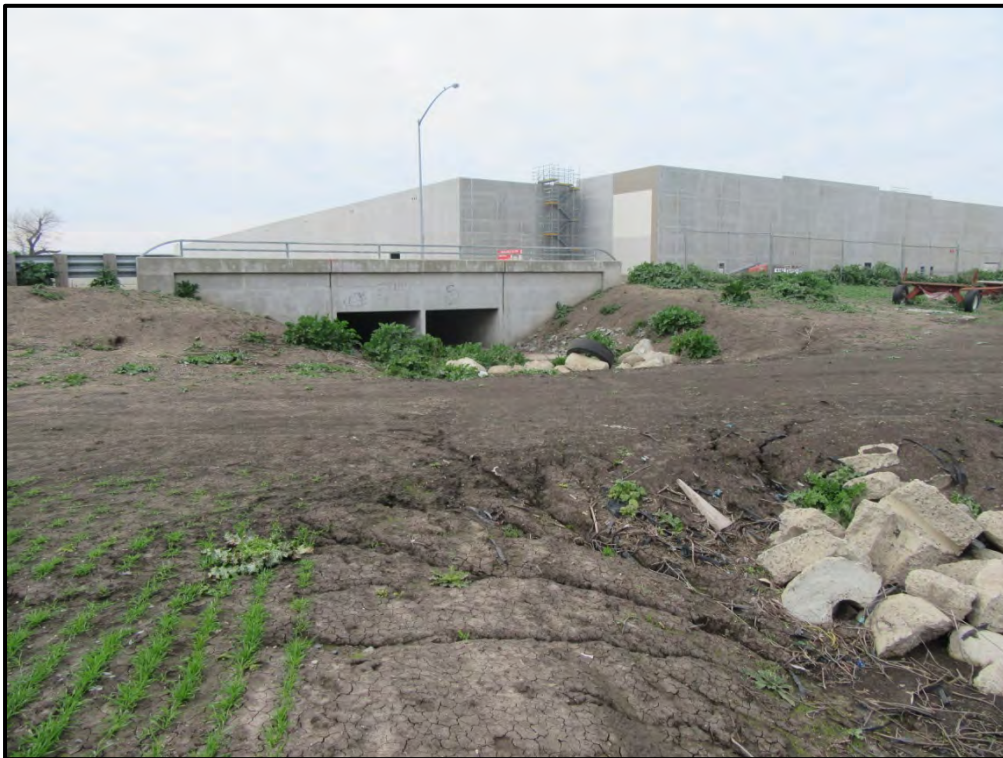
Location where Weber Slough exits the 149+/- acre site through a culvert under Logistics Drive, looking northwest from near the west edge of the parcel; 01/28/19.

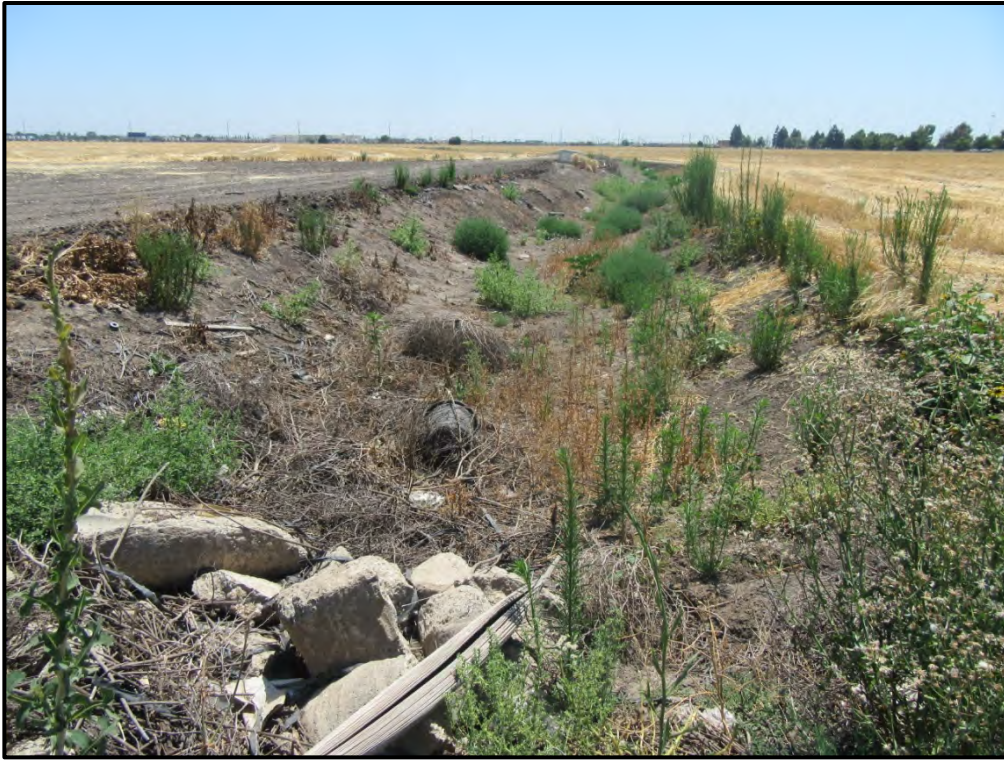
Weber Slough, looking east from the west edge of the site where Weber Slough exits the 149+/- acre site through a culvert under Logistics drive; 07/05/19.

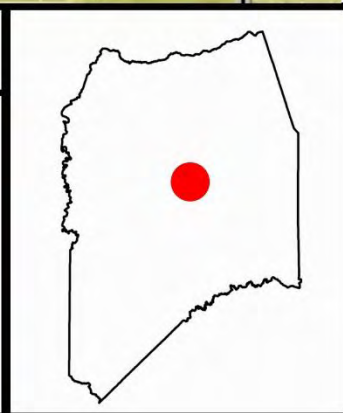
PROJECT DATA:	
SITE AREA	57,134 SQ.
TRA. AREA	2,407,258 SQ.
EXISTING USE	1,133,200 SQ.
WAREHOUSE	1,133,200 SQ.
OFFICE	130,000 SQ.
DEV. YIELD	1.8%
PARKING REQUIRED:	
WAREHOUSE	164 STALS.
OFFICE	40 STALS.
TOTAL	204 STALS.
PARKING PROVIDED:	
AUTOMOBILE	207 STALS.
TRUCK ACCESSIBLE	113 STALS.
TOTAL	320 STALS.
TRUCK DOORS:	
DOCK-HIGH DOORS	22
BUCK-PLATS	42
GRADE-LEVEL DOORS	4

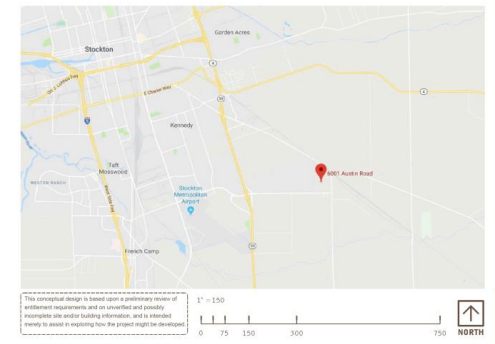
Scheme: 5

SITE AREA: 3	
GROSS:	64.78 AC 2,821,818 SF
WEBER SLOUGH	
NET:	@ 7% 193,796 SF 60.33 AC 2,628,022 SF
BUILDING AREA:	
FOOTPRINT:	1,181,040 SF
MEZZANINE:	@ 10% 118,104 SF
TOTAL BUILDING AREA	
1,299,144 SF	
BUILDING USE:	
WAREHOUSE	1,104,272 SF
OFFICE	@ 15% 194,872 SF
COVERAGE:	
GROSS:	46%
NET:	49%
PARKING REQUIRED:	
DISTRIBUTION	1/2000 SF 250 STALLS
OFFICE	1/4000 SF 151 STALLS
OFFICE	1/250 SF 779 STALLS
TOTAL	1,181 STALLS
PARKING PROVIDED:	
AUTO:	1,184 STALLS @0.91/1000 SF
REQ. ACCESSIBLE	24 STALLS
TRAILER:	82 STALLS

Conceptual Site Plan

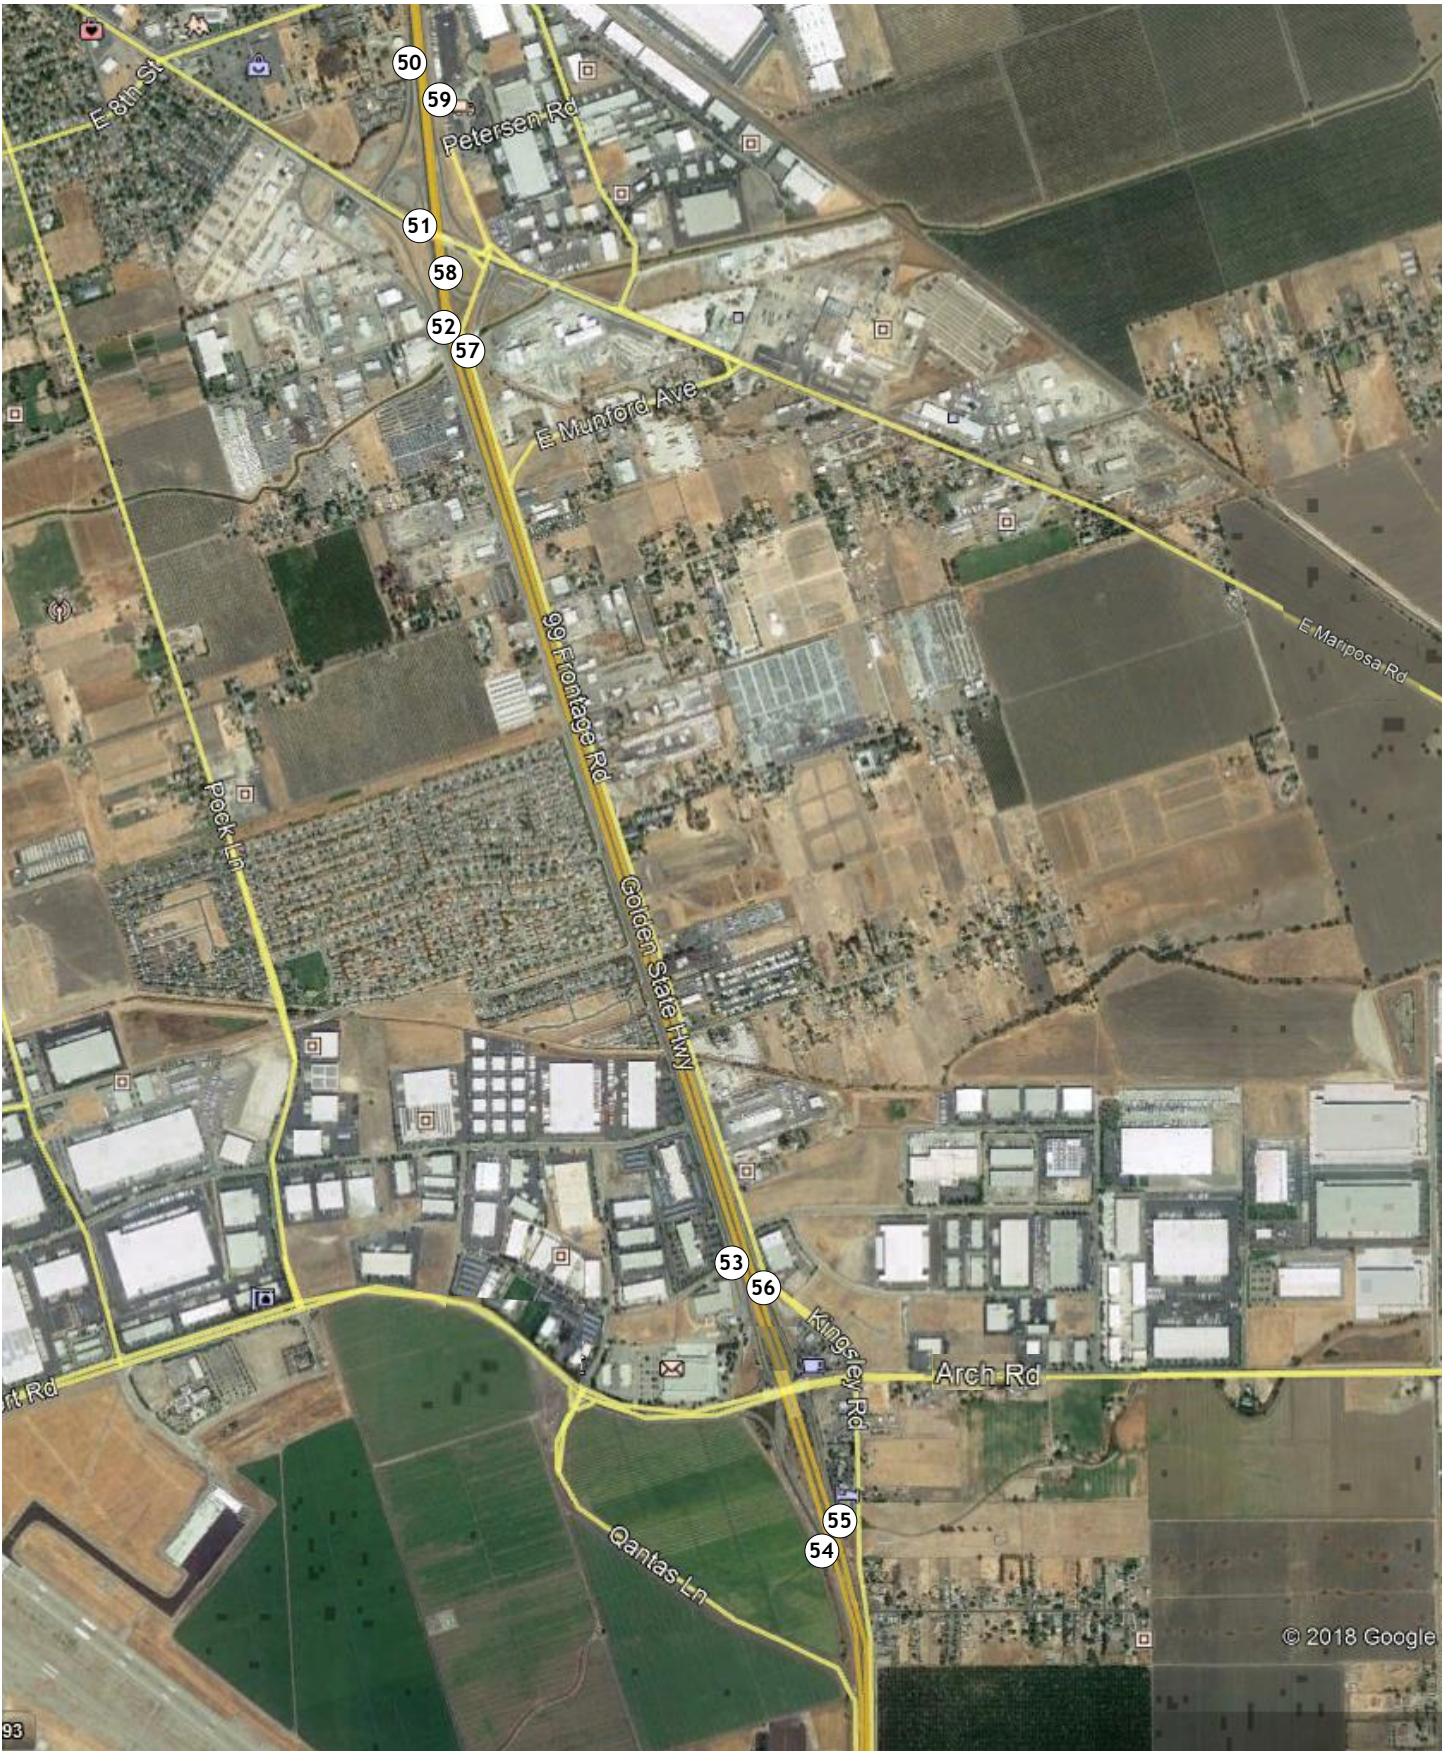
figure 6

The locations of freeway ramp junctions are presented in **Figure 6**. The numbers listed above correspond to the ramp junction numbers on this figure.

STUDY AREA FREEWAY MERGE & DIVERGE RAMPS

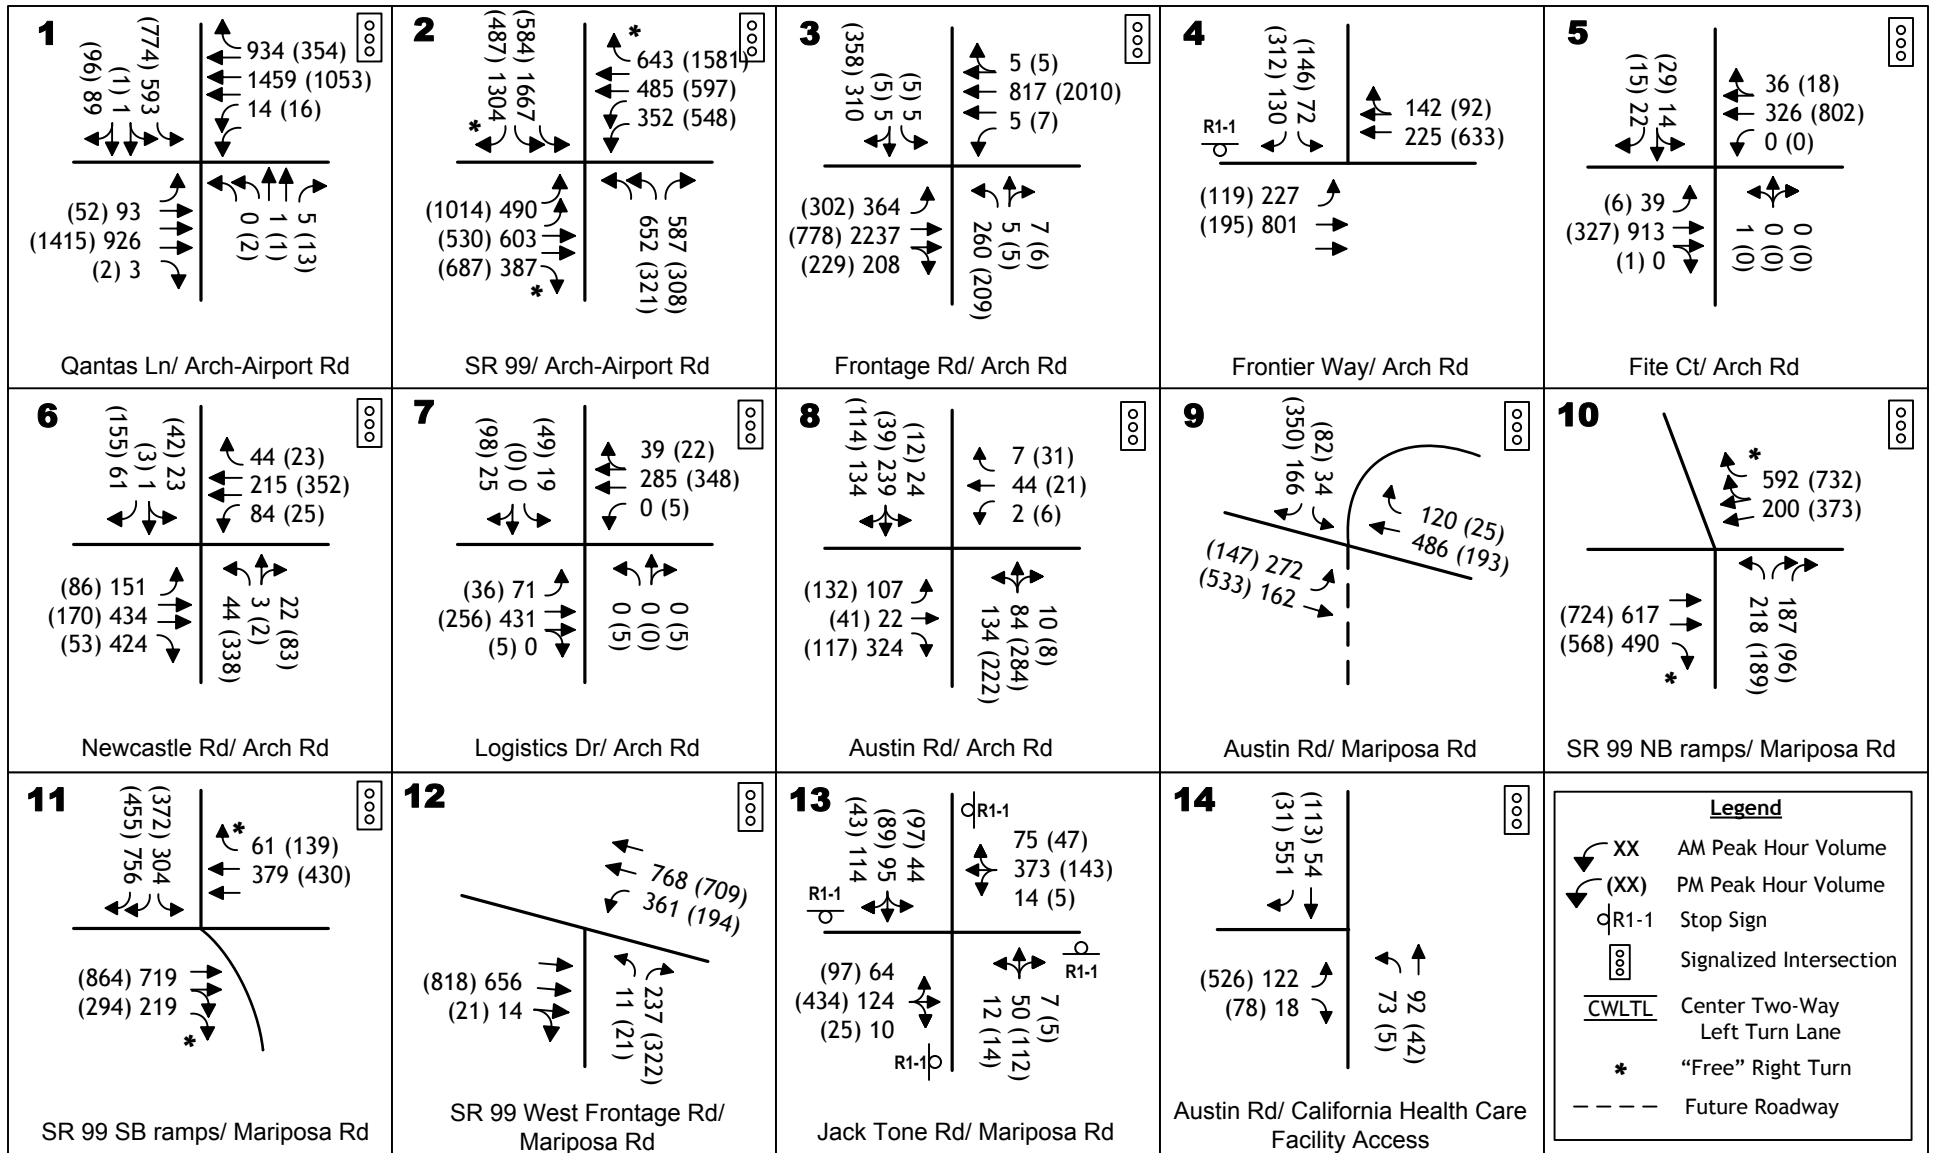
Under EPAP No Project conditions, LOS at 11 of the 14 study intersections would be at acceptable LOS D or better during both the a.m. peak hour and the p.m. peak hour. No improvements are needed at these 11 intersections to achieve acceptable LOS. The following describes the three study intersections that would operate at unacceptable LOS under EPAP No Project conditions.

**EPAP NO PROJECT
INTERSECTION TRAFFIC VOLUMES AND LANE CONFIGURATIONS**

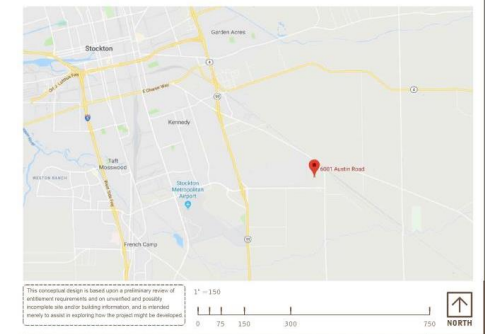
Scheme: 8

PROJECT DATA:		DEVELOPMENT STANDARDS:	
SITE 1 AREA:		ZONING:	
GROSS:	90.25 AC		IL
DETECTION:	@ 11% 3,931,236 SF	MAX. F.A.R.:	0.60
OUT-PARCEL:	419,758 SF	MAX. COVERAGE:	NA
MARIPOSA RD:	66,212 SF	BUILDING SETBACKS:	
WEBER SLOUGH:	125,002 SF	FRONT:	NA
NET:	76.20 AC	SIDE:	NA
	3,319,236 SF	REAR:	NA
TOTAL BUILDING AREA:	636,120 SF	LANDSCAPE SETBACKS:	
BUILDING USE:	WAREHOUSE 604,314 SF	FRONT:	10 FT
OFFICE @ 5% 31,806 SF		SIDE:	NA
COVERAGE:		REAR:	NA
GROSS:	16%	LANDSCAPE REQ.:	
NET:	19%		5%
PARKING REQUIRED:		OFF-STREET PARKING:	
0 - 500,000 SF	1/2000 SF 250 STALLS	STANDARD:	9x19
500,000 SF	1/4000 SF 26 STALLS	COMPACT:	9x15
OFFICE	1/250 SF 127 STALLS	COMPACT %:	25%
TOTAL	403 STALLS	DRIVE AISLE:	25 FT
PARKING PROVIDED:		FIRE LANE:	20 FT
AUTO:	1,140 STALLS	OVERHANG:	2 FT
@1.79/1000 SF		TREE WELL:	6 FT
REQ. ACCESSIBLE	23 STALLS	REQ. PARKING RATIO BY USE:	
TRAILER:	926 STALLS	WAREHOUSE:	1/2000 SF
TRUCK DOCKS:		0 - 500,000 SF	1/4000 SF

▲ DOCK-HIGH DOORS	98	>500,000 SF	1/250 SF
○ GRADE-LEVEL DOORS	23	OFFICE:	1/250 SF
SITE AREA 2		NOTES:	
GROSS:	64.78 AC		
	2,821,818 SF		
WEBER SLOUGH:	@ 7% 193,200 SF		
DETECTION:	@ 9% 267,482 SF		
ROAD:	5,452 SF		
NET:	54.08 AC		
	2,355,684 SF		
BUILDING AREA:			
FOOTPRINT:	1,181,040 SF		
BUILDING USE:			
WAREHOUSE	1,121,988 SF		
OFFICE @ 5%	59,052 SF		
COVERAGE:			
GROSS:	42%		
NET:	50%		
PARKING REQUIRED:			
DISTRIBUTION	1/2000 SF 250 STALLS		
OFFICE	1/4000 SF 155 STALLS		
OFFICE	1/250 SF 236 STALLS		
TOTAL	642 STALLS		
PARKING PROVIDED:			
AUTO:	1,186 STALLS		
@1.1000 SF			
REQ. ACCESSIBLE	24 STALLS		
TRAILER:	82 STALLS		
TRUCK DOCKS:			
▲ DOCK-HIGH DOORS	196		
▲ KNOCK-OUTS OR RATED	38		
○ GRADE-LEVEL DOORS	4

Conceptual Site Plan
